ARCHITECTURAL CASE STUDY

BARFORD ST MICHAEL · OXFORDSHIRE

# Orchard House

*A whole-house retrofit in which fabric, moisture, air, heat and electrical infrastructure were delivered as one coordinated construction system.*

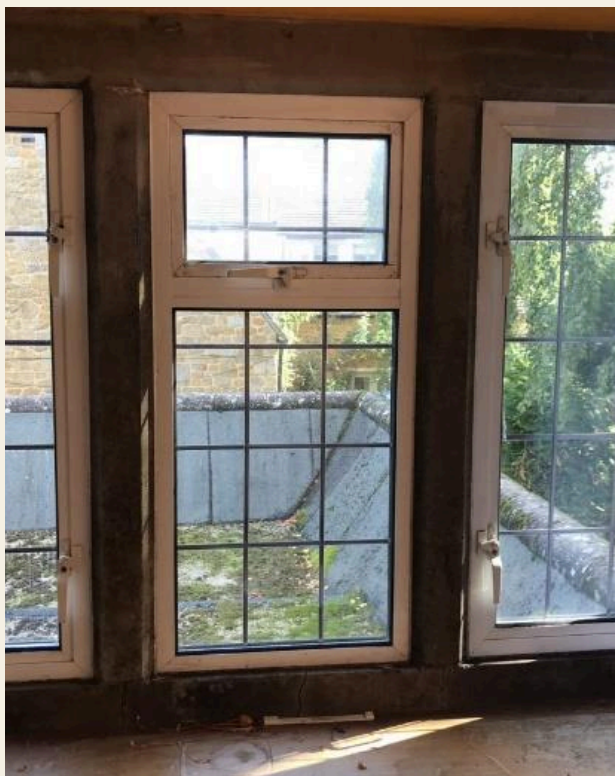
BEFORE · PRE-WORKS SURVEY — PROJECT RECORD

**Uninsulated reconstituted-stone mullions, running cold.** Dark staining and worn finishes at the window junctions marked a thermal bridge repeated around every mullioned opening in the house — the survey logged condensation damage at these details.

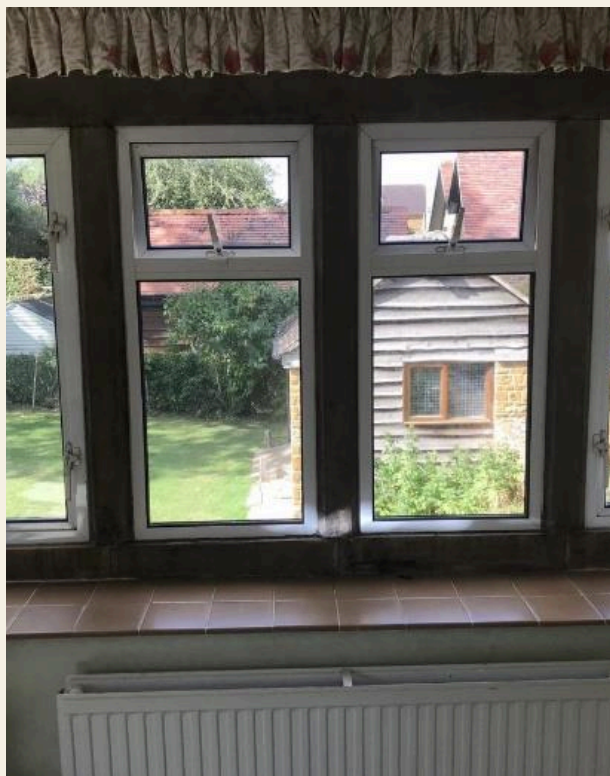
BEFORE · PRE-WORKS SURVEY — PROJECT RECORD

**The pattern at every opening.** Single-glazed leaded lights between cold mullions, a radiator working beneath — the opening type the project rebuilt with bespoke slim-frame double-glazed units, internally insulated surrounds, and junctions sealed and taped as one detail.

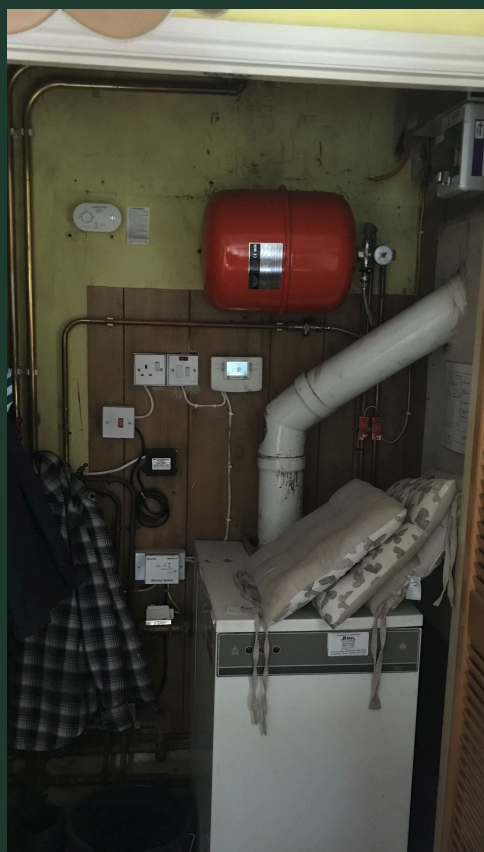
**BEFORE · PRE-WORKS SURVEY — PROJECT RECORD**

**The outgoing infrastructure of oil:** the ageing boiler in its kitchen cupboard, flue and expansion vessel above. The external tank and the 162-litre cylinder went with it — all removed during the works.

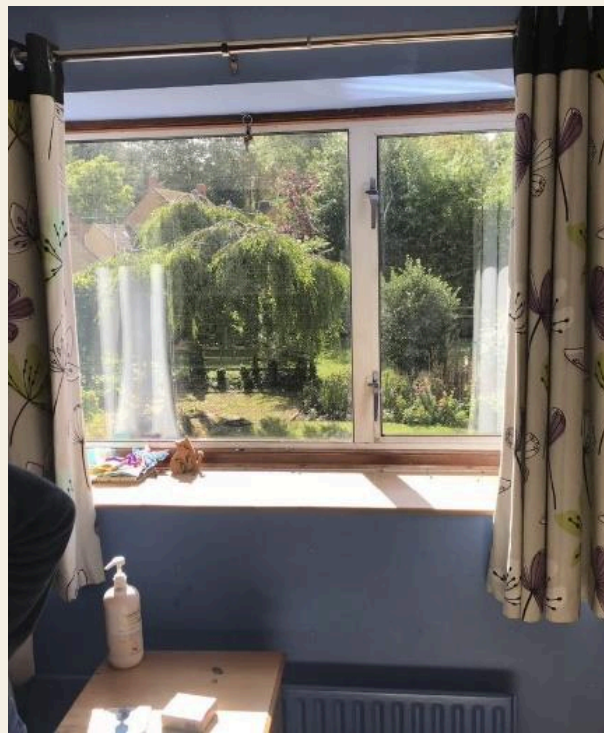
PRE-WORKS SURVEY · PROJECT RECORD

**A first-floor wall as found.** Cold plaster on blockwork, a single-glazed casement, an oil-era radiator. Every external surface in rooms like this received its new layers in one continuous, room-by-room operation.

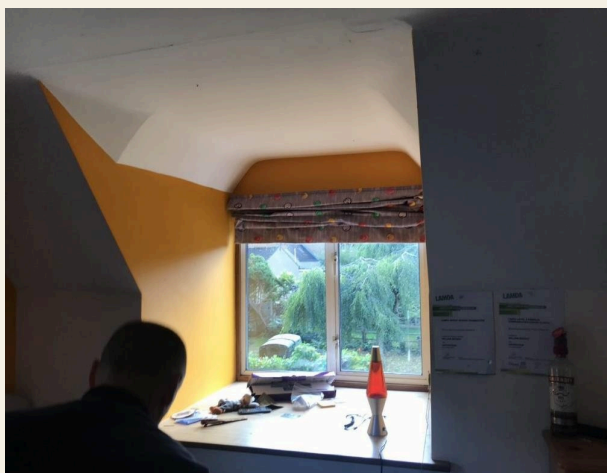
PRE-WORKS SURVEY · PROJECT RECORD

**A bedroom slope as surveyed.** Plasterboard over rafters with little behind it — scheduled for opening up and wood fibre between the timbers.

Only after inspection were the slopes re-lined and skimmed — work concealed is work verified first, a principle that runs through the whole project.<sup>19</sup>

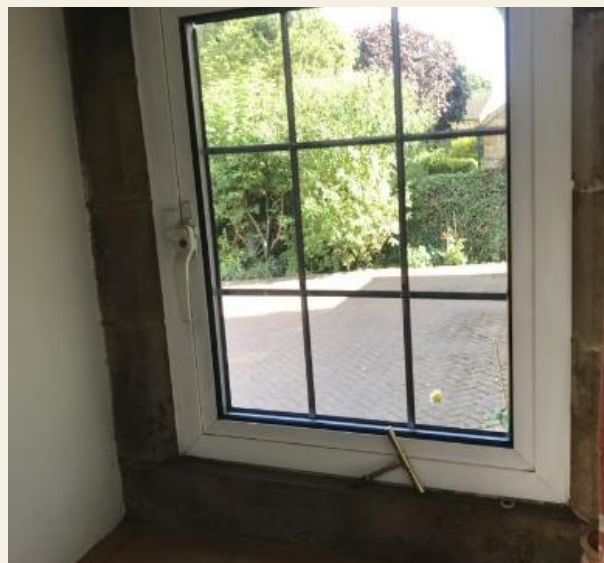
## PRE-WORKS SURVEY · PROJECT RECORD

The mullioned windows give the house its face. They were also its weakest thermal detail: the reconstituted-stone jambs and mullions were uninsulated, bridging straight through the wall and condensing — the published account records damp and mould at these junctions, and notes that specialist stonemasons were consulted on the solution.<sup>5</sup> The survey photographs show the cost plainly: staining and worn finishes tracking the stone, cold cills below the old glazing.

**The junction as found.** A leaded unit set directly in the reconstituted-stone surround — no insulation between stone and room, the whole depth of the jamb running cold.

The answer was surgical. Damaged surrounds were repaired; the old glazing came out; new slim double-glazed units went in; and then — the step that turns a window replacement into a retrofit — the stone surrounds themselves were insulated internally with a thin, moisture-compatible layer, with calcium-silicate (Calcitherm-type) board recorded for these reveals in the published account.<sup>5</sup> Reveals, tapes, plaster and the room's wall insulation all meet here, so the work was done concurrently with the IWI, as one junction.<sup>20</sup>

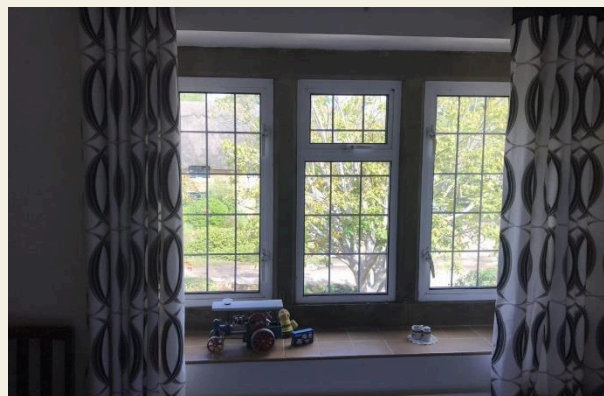
## PRE-WORKS SURVEY · PROJECT RECORD

**The stone on the room side:** mullions and reveals presented cold faces to every room — the surfaces later lined with thin moisture-compatible insulation.

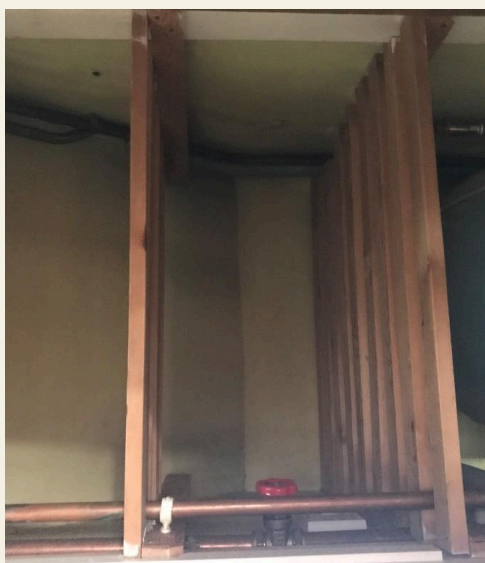
## PRE-WORKS SURVEY · PROJECT RECORD

**Concealed routes as found.** Pipework and services rising through unsealed voids — every one a leak path to be sealed, and a route fixed before the fabric closed.

At windows, impregnated tape linked frame to air barrier. At service entries, penetrations were sealed with tapes and grommets rather than mastic smears. At the floor voids, insulation passed through instead of stopping short. At the skelings, the vapour-control layer was taped at every joint. And in the walls themselves, the continuous lime plaster acted as a robust, repairable air-control layer that no future picture hook can easily defeat.<sup>17</sup>

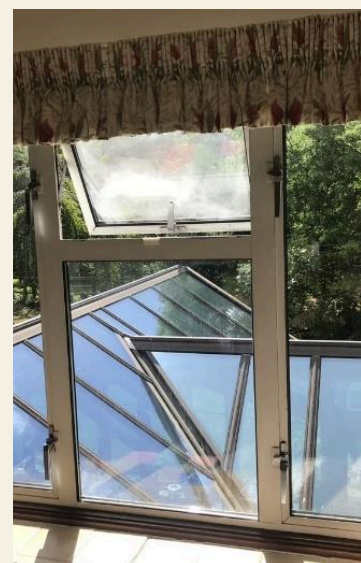
## PRE-WORKS SURVEY · PROJECT RECORD

**The frame-masonry junction:** a leak path until taped — window, reveal insulation and air barrier were specified as one detail.

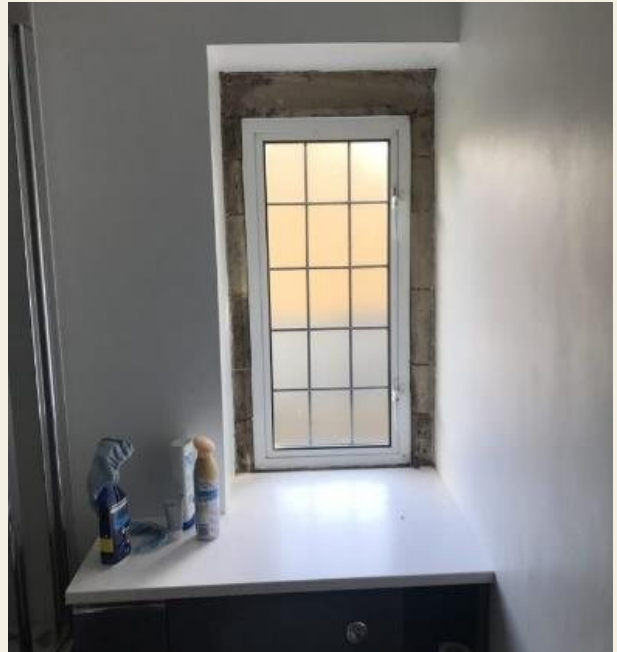
## PRE-WORKS SURVEY · PROJECT RECORD

**A wet room as found.** No mechanical extract, no background vent — moisture managed only by leakage and an openable window. The new system put humidity-controlled extraction here instead.

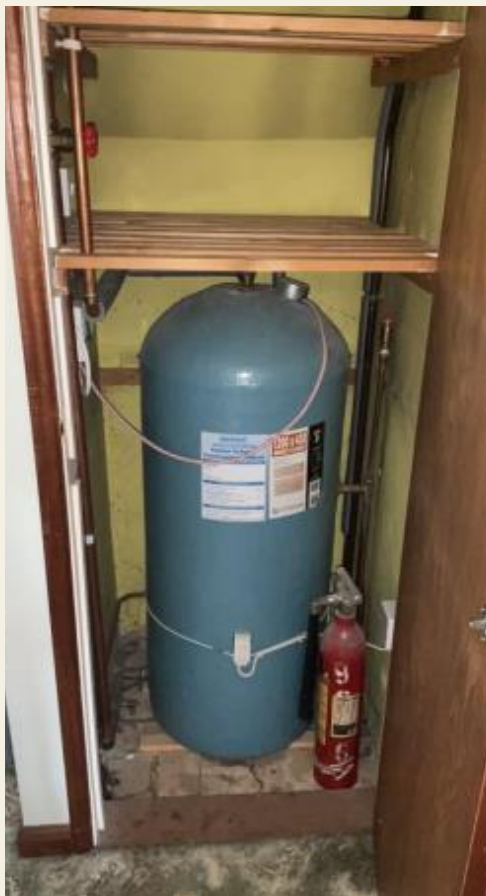
### PRE-WORKS SURVEY · PROJECT RECORD

**What the upgrade replaced:** the 162-litre cylinder in the first-floor airing cupboard — undersized for heat-pump operation. The record specified insulated storage of roughly 300 litres, plumbed and controlled for low-temperature flow.

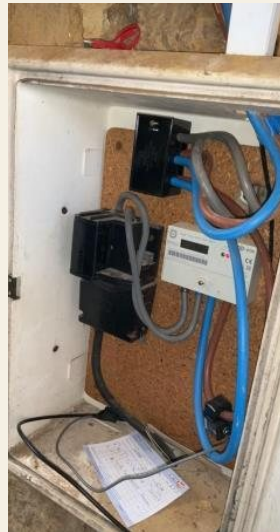
PRE-WORKS SURVEY · PROJECT RECORD

**Inherited infrastructure:** the meter cabinet in the garage and the old consumer-unit arrangement — the starting point for a safer, re-planned electrical installation.

The consumer unit and the solar-PV controller were relocated to the garage; sections of degraded wiring were replaced; the kitchen's electrical provision was separated and reconfigured for its renewal; smoke and heat alarms, downlights, under-cabinet lighting, additional sockets and Cat6 data were installed. Dedicated supplies were run for the heat pump and the ventilation system, and the work closed with testing, earthing verification and Part P registration.<sup>33</sup>
