ARCHITECTURAL CASE STUDY

BARFORD ST MICHAEL · OXFORDSHIRE

# Orchard House

*A whole-house retrofit in which fabric, moisture, air, heat and electrical infrastructure were delivered as one coordinated construction system.*

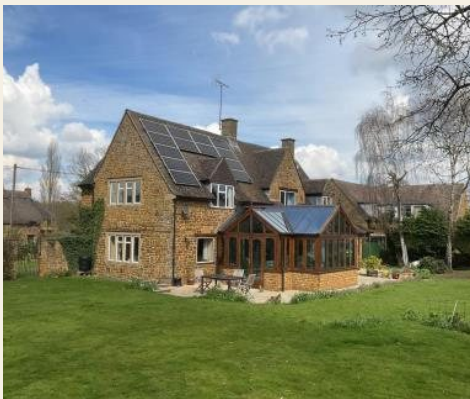
PRE-WORKS PHOTOGRAPH · PROJECT RECORD

**The rear elevation before the works.** Existing solar array and conservatory; the oil tank stood against the garage wall.

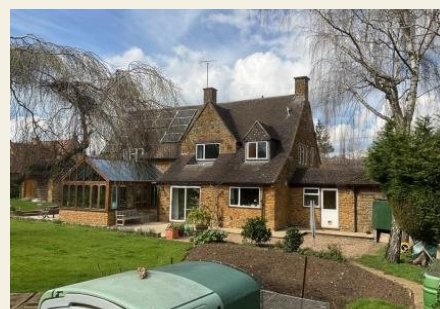
### PROJECT RECORD

**Garden elevation** before the works, oil tank against the garage wall.

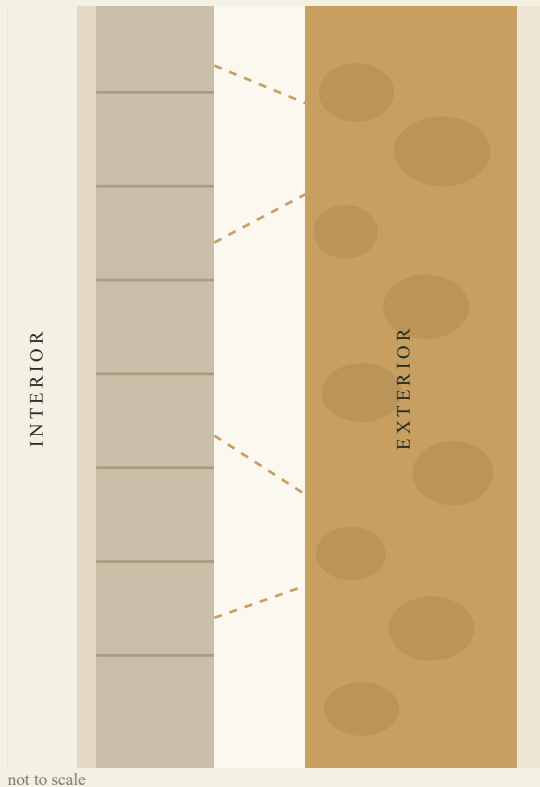
## INTERPRETIVE DIAGRAM

- a Existing internal plaster
- b Concrete-block inner leaf
- c Irregular, unfilled cavity — unsuitable for cavity fill
- d Rubble-stone outer leaf, lime-pointed

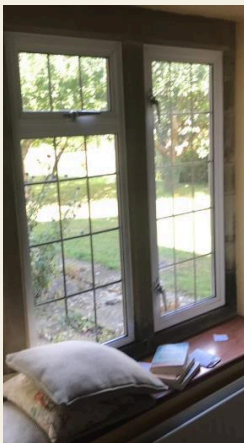
### PRE-WORKS SURVEY · PROJECT RECORD

#### Preparation is the work.

Finishes, joinery and fitted furniture came off walls like these before parge and boards — the unglamorous stage on which performance depends.

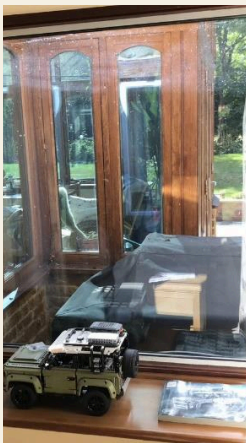
### PRE-WORKS SURVEY · PROJECT RECORD

#### Rebuilt to the room it was.

Bays, reveals and cills like these were stripped, insulated and re-plastered, with skirtings and mouldings reinstated per the record.

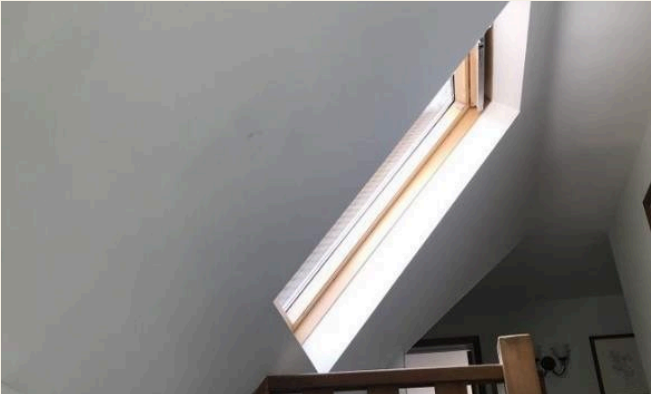
## PRE-WORKS SURVEY · PROJECT RECORD

**The landing slope,** rooflight above the stair — one of nine zones opened and insulated.

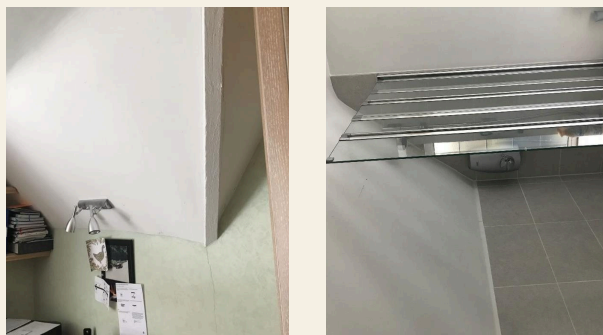
PRE-WORKS SURVEY · PROJECT RECORD

**Master bedroom and family bathroom slopes** — lined, insulated and re-skimmed; bathroom-rated board used in the wet rooms.

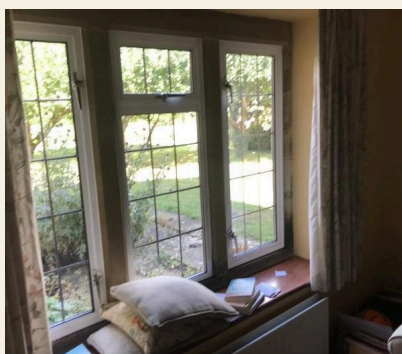
PRE-WORKS SURVEY · PROJECT RECORD

**Small sitting room**, three-light mullioned opening as found.

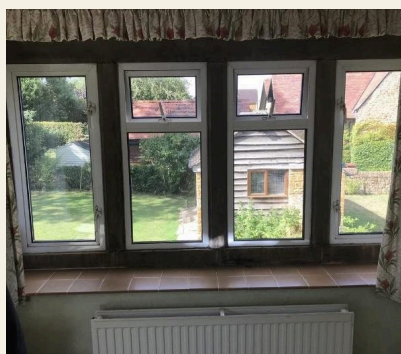
PRE-WORKS SURVEY · PROJECT RECORD

**Master bedroom**, the four-light side opening as found.

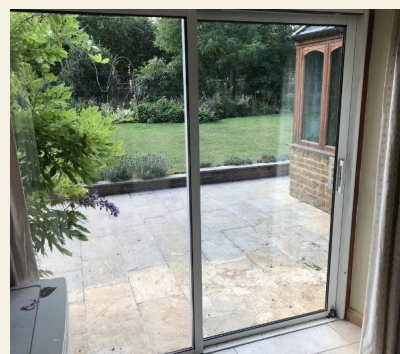
PRE-WORKS SURVEY · PROJECT RECORD

**Dining room**, the patio doors to be replaced.

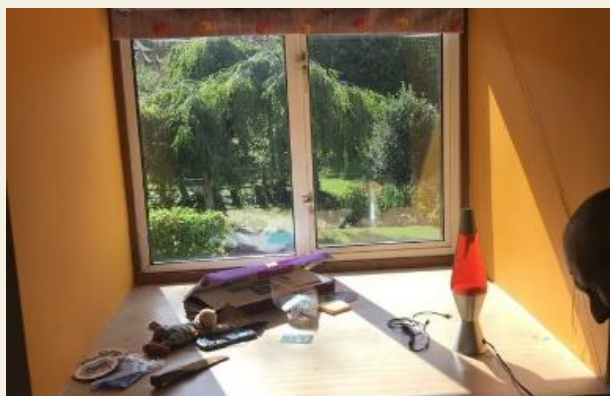
## PRE-WORKS SURVEY · PROJECT RECORD

**Deep reveals, cold surrounds:** reveal faces were lined with insulation as part of the window package.

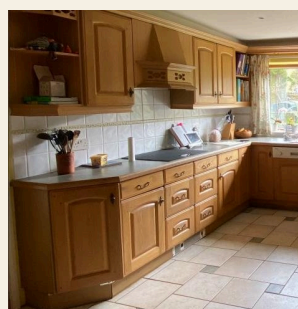
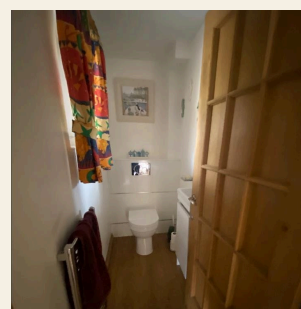
## PRE-WORKS SURVEY · PROJECT RECORD

**Kitchen and family bathroom** — two of the five extract locations surveyed for the new system.

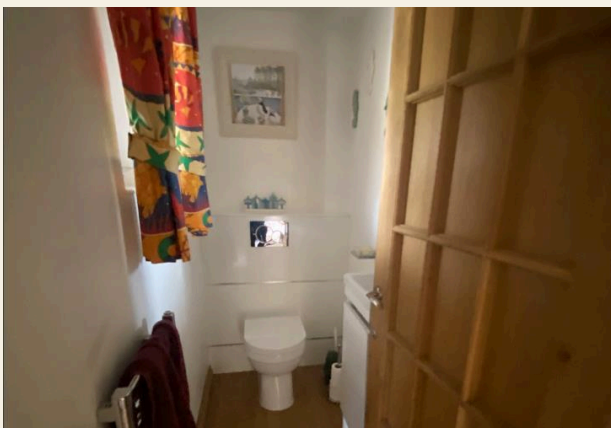
## PRE-WORKS SURVEY · PROJECT RECORD

**The ground-floor cloakroom:** among the wet spaces surveyed for the extract and transfer-path plan.

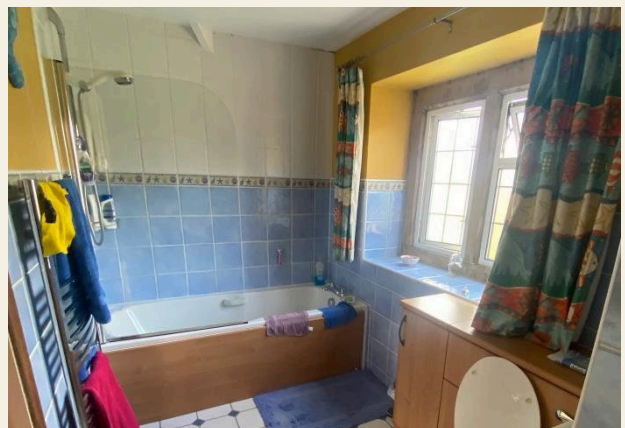
## PRE-WORKS SURVEY · PROJECT RECORD

**The en-suite as found** — one of the wet rooms whose extraction was re-specified in the new system.

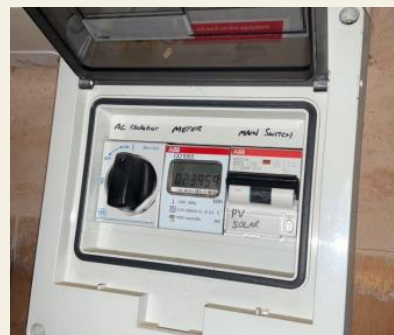
### PRE-WORKS · PROJECT RECORD

**Supply readiness checked:** metering and isolation surveyed for the new all-electric plant.

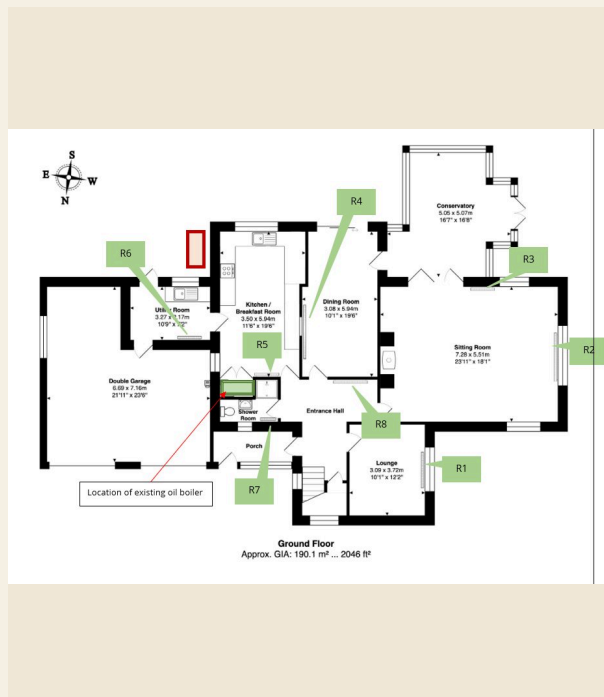
## PROJECT RECORD · 699 TR H4

**The heating map.** Every emitter logged by room, the outgoing boiler position marked, and the proposed heat-pump location fixed against the east kitchen wall.

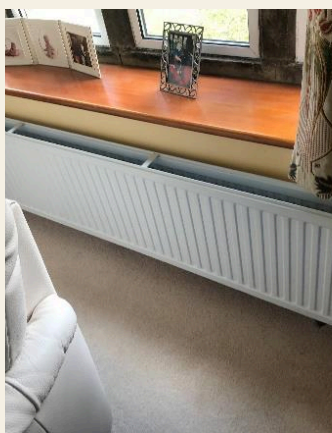
### PRE-WORKS SURVEY · PROJECT RECORD

**The emitter audit fed the hydraulics** — flow temperatures, pipe sizing and the balance between rooms.

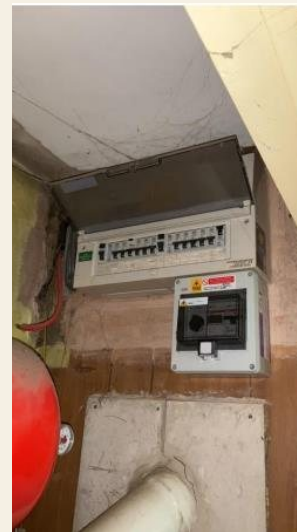
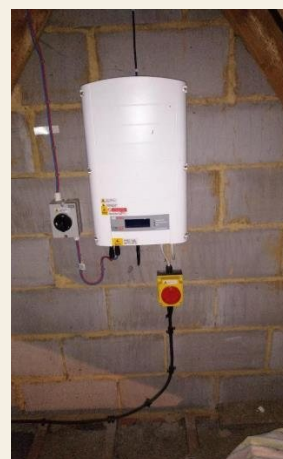
PRE-WORKS SURVEY · PROJECT RECORD

**Inherited infrastructure:** the meter cabinet in the garage and the old consumer-unit arrangement — the starting point for a safer, re-planned electrical installation.

The consumer unit and the solar-PV controller were relocated to the garage; sections of degraded wiring were replaced; the kitchen's electrical provision was separated and reconfigured for its renewal; smoke and heat alarms, downlights, under-cabinet lighting, additional sockets and Cat6 data were installed. Dedicated supplies were run for the heat pump and the ventilation system, and the work closed with testing, earthing verification and Part P registration.<sup>33</sup>

**Relocate & protect.** Consumer unit and PV controller moved to the garage; earthing and circuit testing; Part P registration.

**Renew & reconfigure.** Degraded wiring replaced; kitchen provision separated and rebuilt for the new layout.

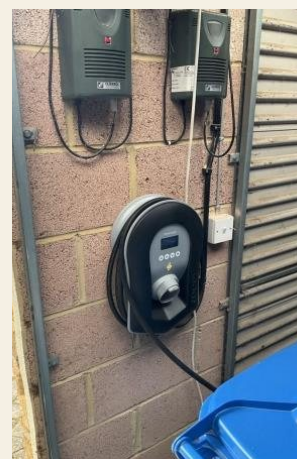
PRE-WORKS SURVEY · PROJECT RECORD

**Existing generation and charging** — the solar array's inverter and the EV charge point were integrated into the relocated, re-planned electrical heart of the house.

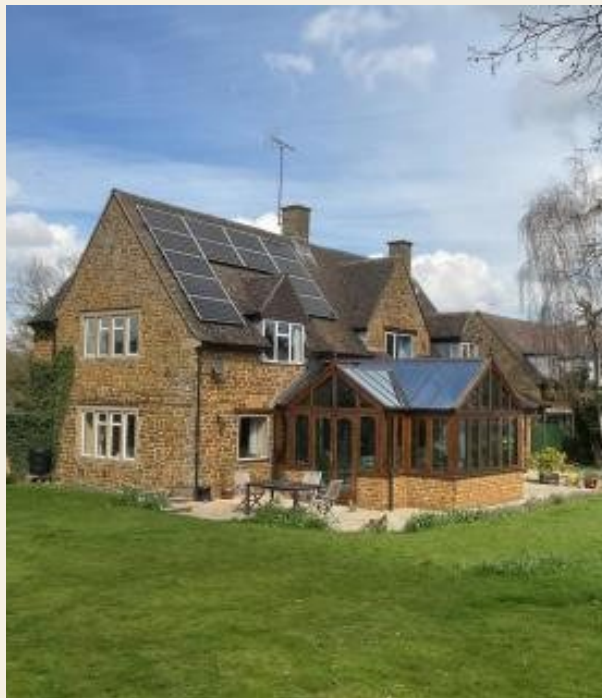
## PROJECT RECORD

**Unchanged where it matters.** The stone elevations, mullioned openings and roofline all remain — the retrofit is in the performance, not the appearance.

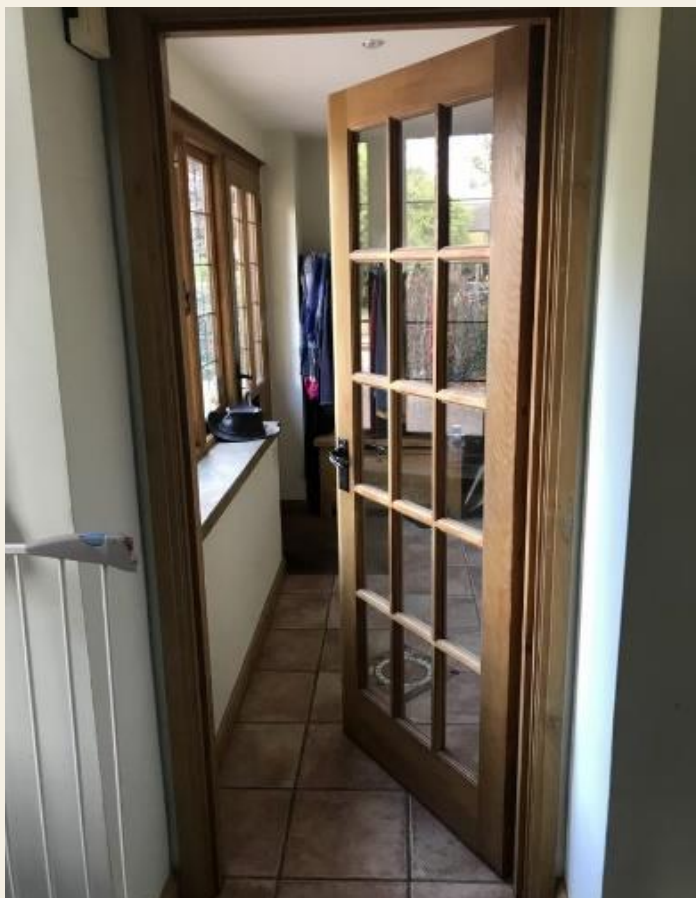
## PRE-WORKS SURVEY · PROJECT RECORD

**A house, not a site.** Reinstatement ran to a domestic standard — seven internal doors, joinery, skirtings and mouldings renewed or replicated as part of the record's scope.

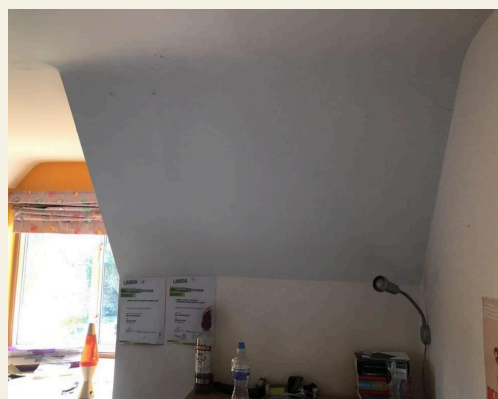
## PRE-WORKS SURVEY · PROJECT RECORD

**Rooms handed back to daily life** — every slope and wall in rooms like this rebuilt, plastered and decorated, with the insulation invisible behind the finish.
